GIS BASED MAPPING AND STATUS OF WATER QUALITY IN LAKES FOR SUSTAINABLE RESTORATION

Dr. BC Nagendra Prasad

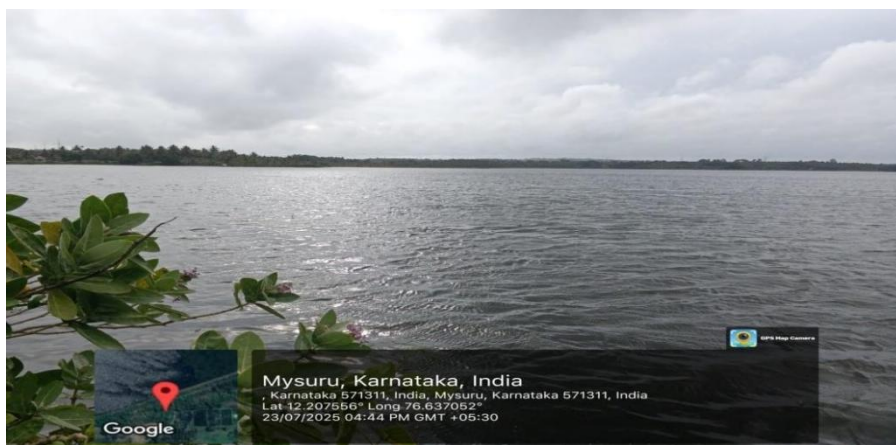
Fig 1.1: This figure shows the GPS image of Yennehole Lake

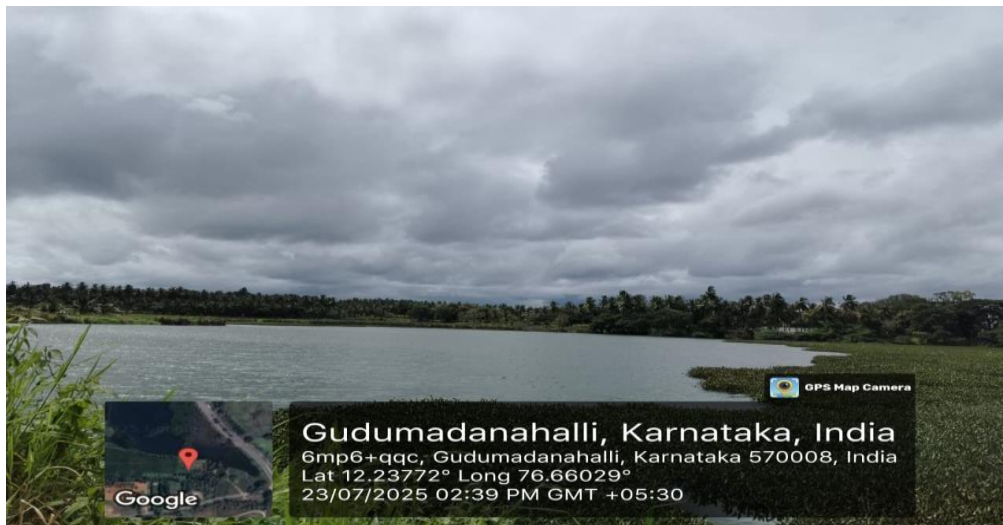
Fig 1.2 : This figure shows the GPS image of Shetty Kere

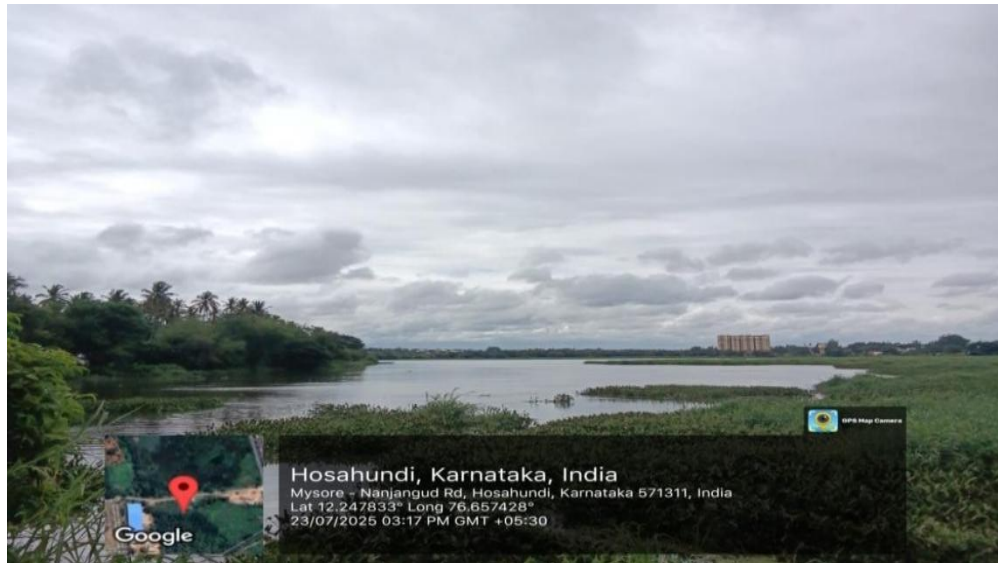
Fig 1.3: This figure shows the GPS image of Dalavayi Lake

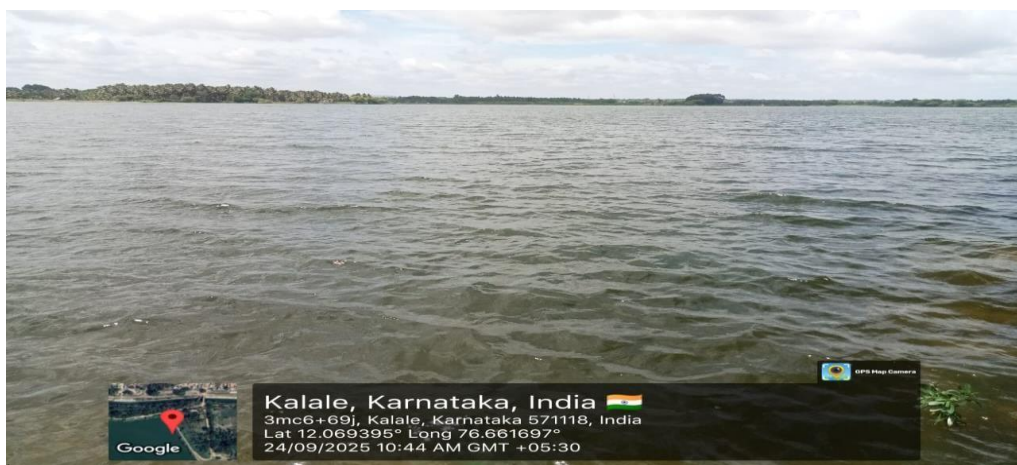
Fig 1.4: This figure shows the GPS image of Kalale Lake

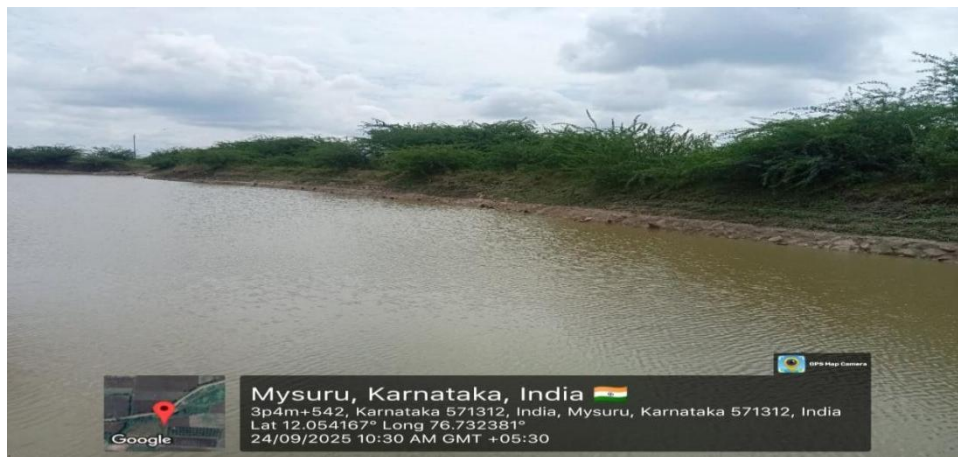
Figure 1.3: This figure shows the GPS image of Gonathagala lake

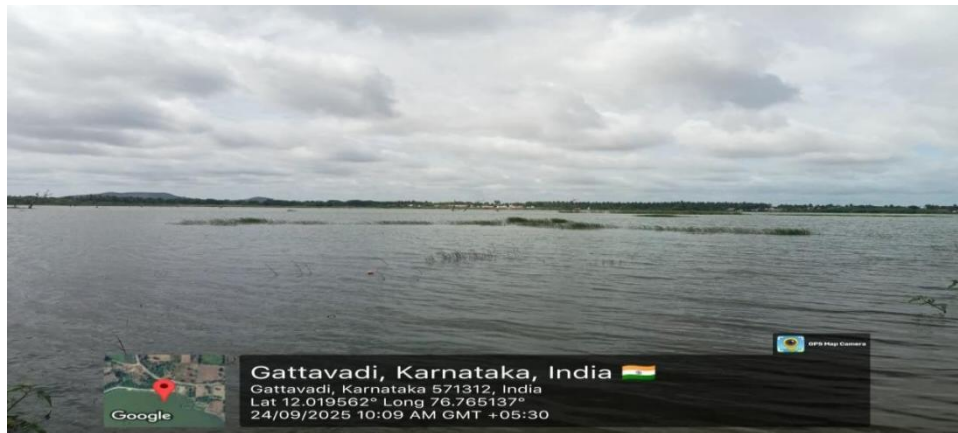
Figure 1.4 : This figure shows the GPS image of Halepura Lake
